Experiment 949
Technical Note No. xxx

Addition to Bad Run List via `bad_run_02.function`

Benji Lewis

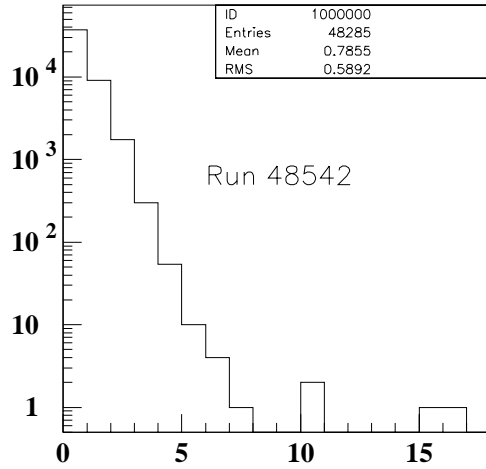
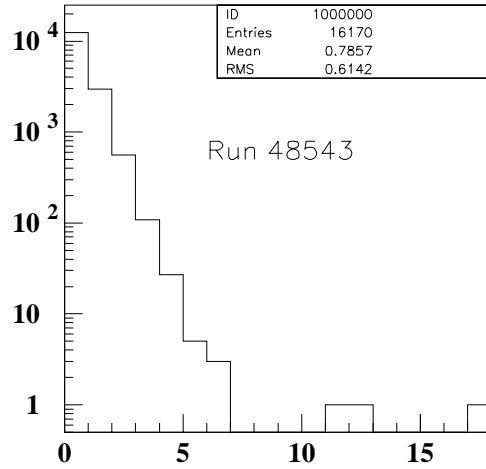
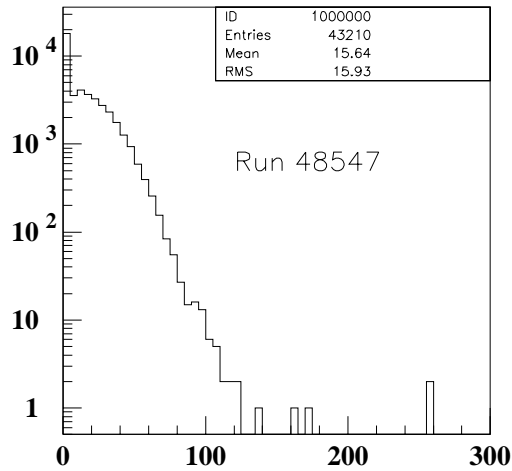
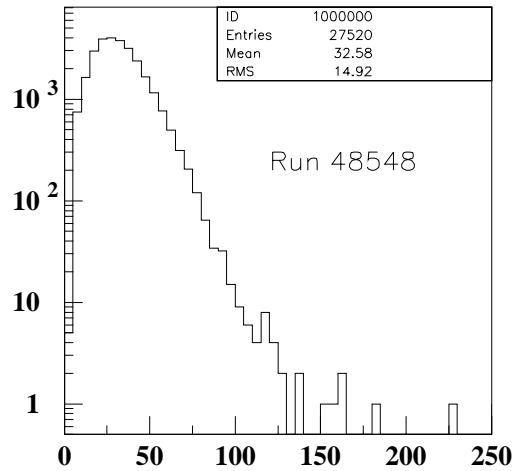
Figure 1: Number of hits in Beam-Wire Chambers for runs of interest. Run 48538 is a typical run that indicates that the Beam-Wire Chambers are in working order after run 48547.

Run 48534 isn't plotted because all events have 0 hits which means zero voltage on the beam-wire chambers. As seen in Figure 1 runs 48542 and 48543 have hits in the beam-wire chambers, but the total number of hits are very small. This indicates that there was some high voltage, but not the optimal voltage is not set or a possible problem with the gas mixture in the chamber. The number of hits in run 48547 shows that the beam-wire chambers recovered sometime during the run, notice there are a large number of events with zero hits.

These are the entries I found in the Electronic Logbook during the Beam-Wire problems. As seen the BWPC went down when the isobutane tank was changed. This also effected the RSSC.

There is sufficient evidence to add runs 48534, 48542,48543,48547 to the bad run list. This has been done to both the \$PASS2_RUN/bad_run.02002 run list for pass2 processing. Also, these runs have been added to the bad_run_02.function used in the comis analysis.
